TECHNICAL ASSISTANCE TEAM FOR EMERGENCY RESPONSE REMOVAL AND PREVENTION
EPA CONTRACT 68-01-7367

Re: Torch Lake Site Investigation, Hubbell, Michigan
TDD# 5-9007-31

SITE PHOTOGRAPHS

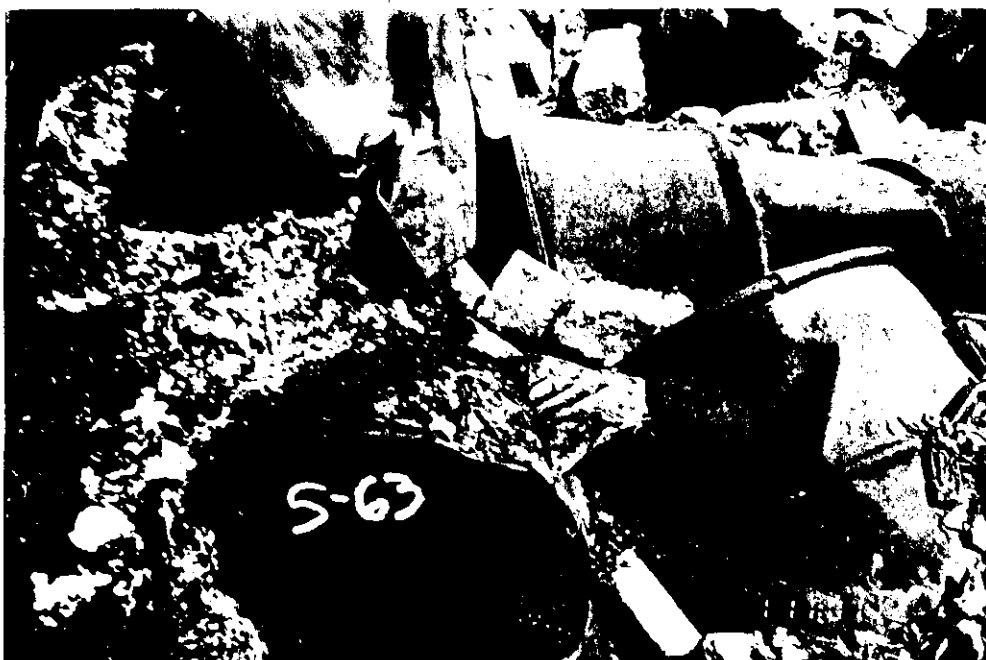
PHOTO NO: 01
 SITE NAME: TORCH LAKE SAMPLING
 Hubbell, Michigan
 DESCRIPTION: Solid drum sample #63 was collected along shoreline near an abandoned plating warehouse (Location 1). Sample appeared light brown and powdery.
 DATE: 08-01-90
 PHOTOGRAPHER: D. Locy *[Signature]*

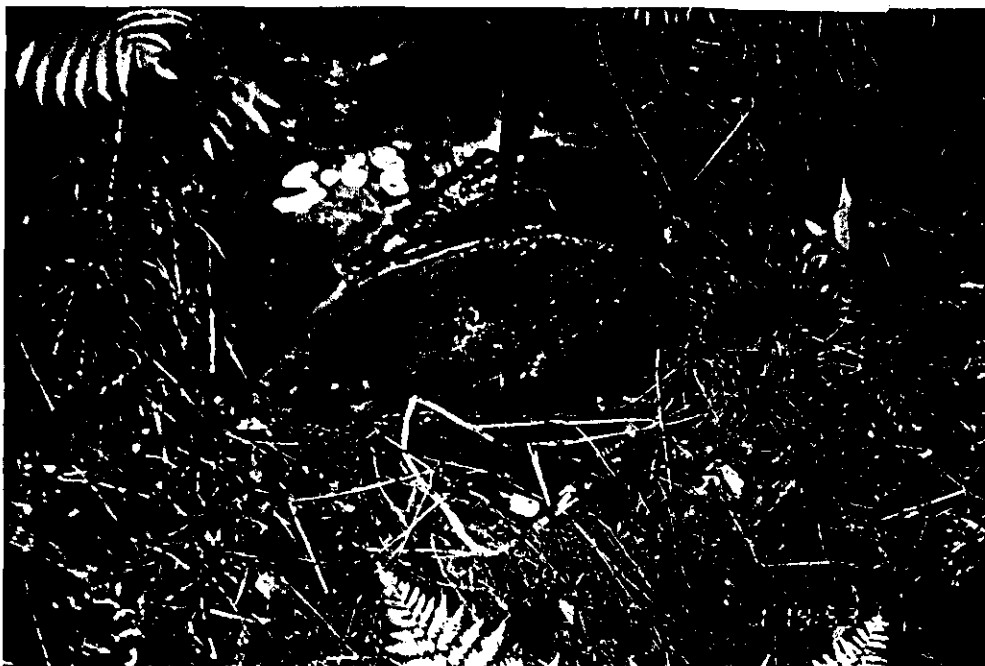
On August 24, 1990, the TAT received the analytical results from EMS Heritage Laboratories. The analytical results indicated that drum sample S-68 is a Resource Conservation and Recovery Act (RCRA) F-Listed hazardous waste (40 CFR Part 261.31). The F-Listed waste constituents identified in sample S-68 were: methyl isobutylketone, o-dichlorobenzene, m,p-cresol, o-cresol, total xylene, and styrene. The analytical data also indicated the presence of several different VOCs in drum samples S-64, S-66, S-67, and S-69. The analytical results, which are summarized in Tables 1, 2, and 3, did not indicate the presence of RCRA hazardous waste in any other drum samples.

PHOTO NO: 06
 SITE NAME: TORCH LAKE SAMPLING
 Hubbell, Michigan
 DESCRIPTION: Liquid drum Sample #68 was
 collected in the woods
 between the State Route 41
 and the lake (Location 4).
 Sample was a black colored
 liquid.
 DATE: 08-01-90
 PHOTOGRAPHER: D. Locy *[Signature]*

At the request of U.S. EPA On-Scene Coordinator (OSC) Walter Nied, the TAT prepared a draft action memo (Attachment C) for a removal action at the Torch Lake site. The draft action memo was submitted to OSC Nied on September 5, 1990

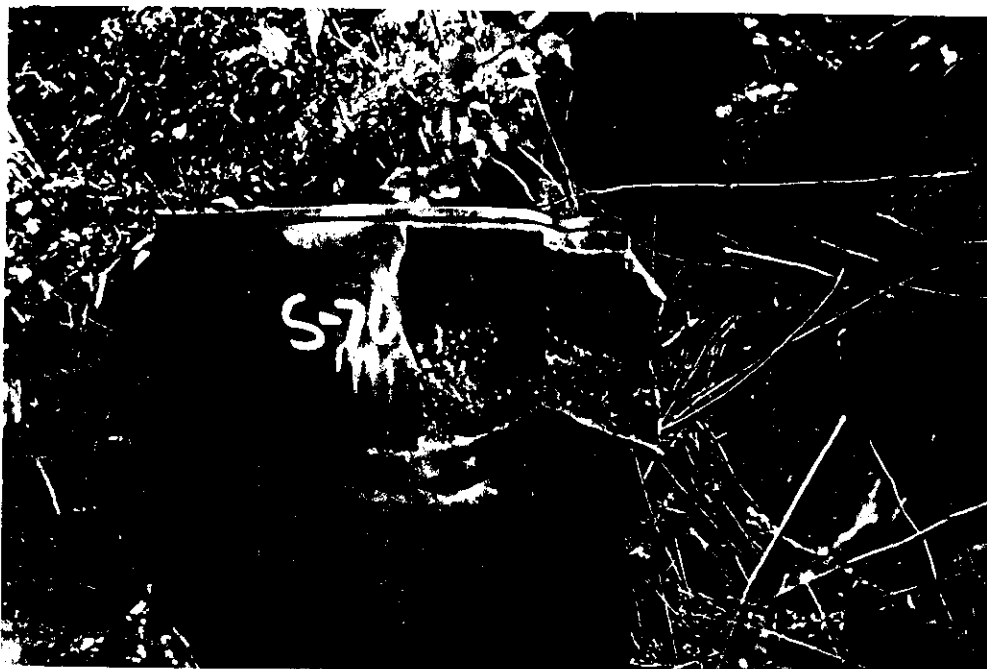
PHOTO NO: 08
 SITE NAME: TORCH LAKE SAMPLING
 Hubbell, Michigan
 DESCRIPTION: Solid drum sample #70 was
 collected along a bank near
 the old wastewater treatment
 lagoons (Location 3). Sample
 appeared lava-like.
 DATE: 08-01-90
 PHOTOGRAPHER: D. Locy *DL*
